Grease pump Kit

Description

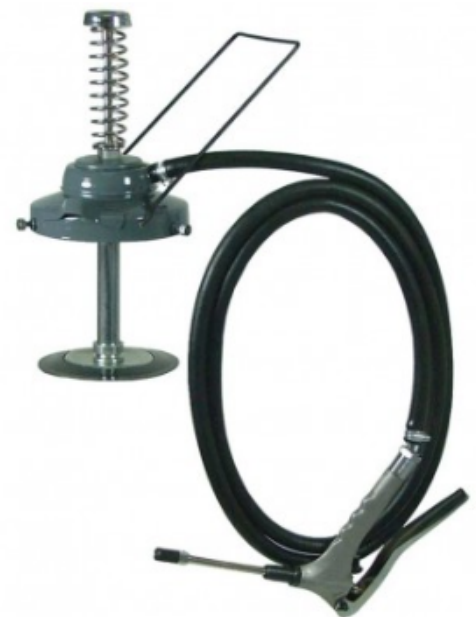
How to clean the strainer

Should the strainer need cleaning, (refer trouble shooting guide, page 3, item C(b)), undo the nut at the base of the pump spring with a suitable spanner, remove assembly, lever off strainer cover and clean the appropriate parts as illustrated.
